# HOME INSPECTION REPORT

**Inspection Address: 288 Sunny Way**

**Inspection Date: 2022/9/15**

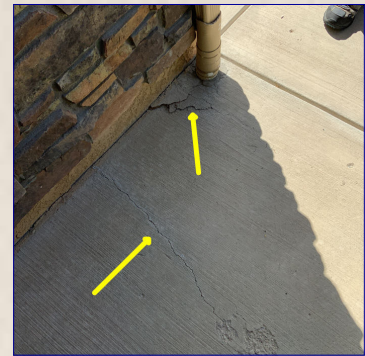
The Service Walk View

There is spalling on the service walks. Spalling is a common surface imperfection. In most cases, the defect does not affect the slab's service life if untreated. Recommend a professional contractor repair to help prevent additional damage as needed.

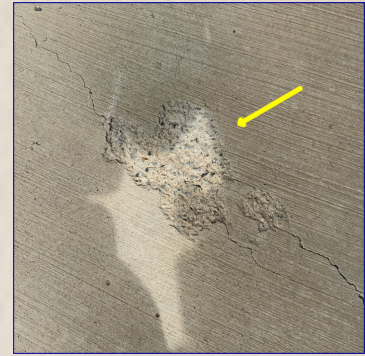
The Service Walk View

There is spalling on the service walks. Spalling is a common surface imperfection. In most cases, the defect does not affect the slab's service life if untreated. Recommend a professional contractor repair to help prevent additional damage as needed.

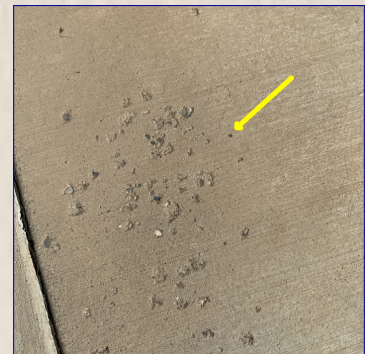
The driveway has areas of spalling. Spalling is a common surface imperfection. In most cases, the defect does not affect the slab's service life if untreated. Recommend a professional contractor repair to help prevent additional damage.

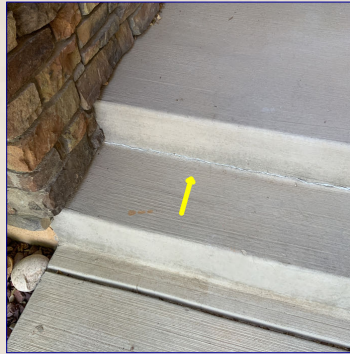
There is a crack at the steps.  
Recommend a professional contractor  
seal the crack to help prevent  
additional damage to the concrete.

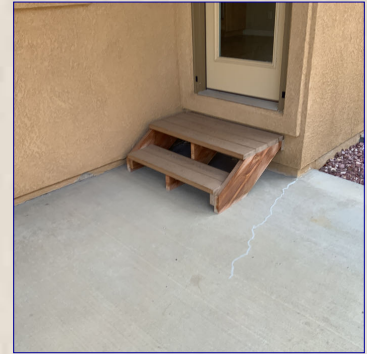
The Steps/Stoop View

There are open risers on the exterior wood stairs, which is a potential safety concern. Recommend using additional caution in these areas. Install proper risers for added safety.

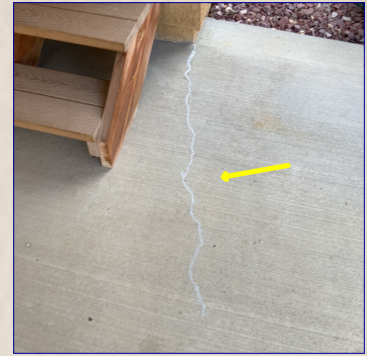
The patio has typical cracks. Recommend a professional contractor seal the cracks to help protect the cement from damage.

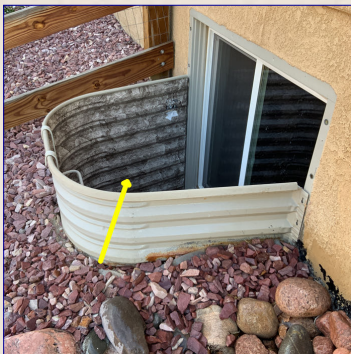
Window well covers are missing in one or more locations. Adding window well covers will help prevent moisture and debris from entering the window wells. In addition, an open window well is a falling hazard. Recommend adding window well covers.

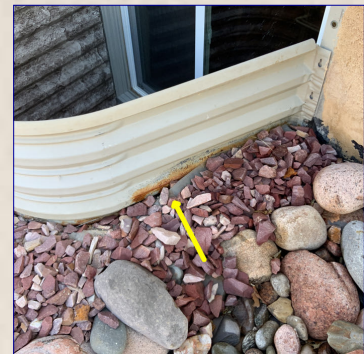
The window well had some rusting. Recommend monitoring and contacting a licensed contractor as needed.

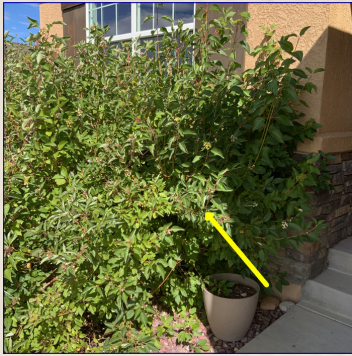
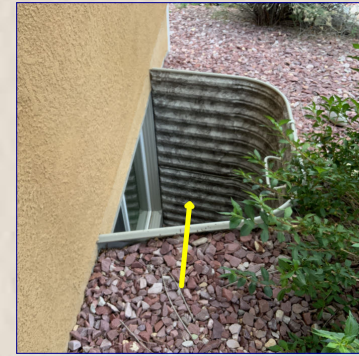
There is vegetation in contact with the house. Recommend trimming trees/vegetation, so it doesn't come into contact with the home.

Window well covers are missing in one or more locations. Adding window well covers will help prevent moisture and debris from entering the window wells. In addition, an open window well is a falling hazard. Recommend adding window well covers.

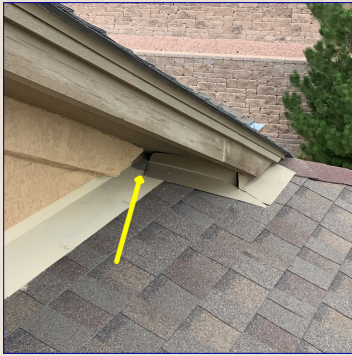
There were gaps at the flashing. Recommend a licensed roofer evaluate repair as needed.

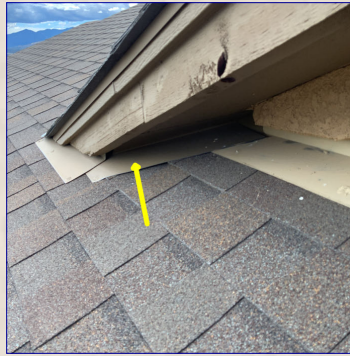
There were gaps at the flashing. Recommend a licensed roofer evaluate repair as needed.

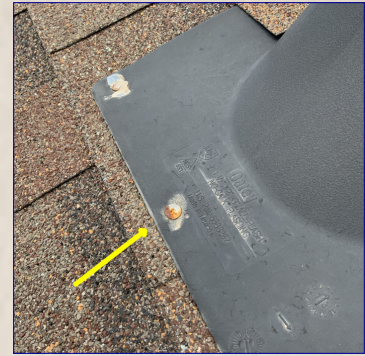
There are exposed nail heads securing the flashing to the roof. Exposed nail heads can allow water to penetrate the roof. Recommend a licensed roofer to seal the nail heads.

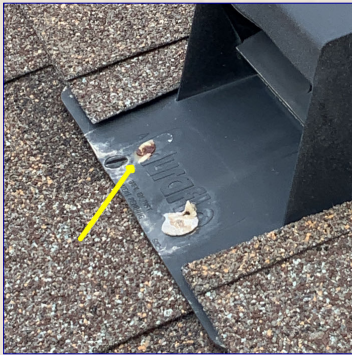
There are exposed nail heads securing the flashing to the roof. Exposed nail heads can allow water to penetrate the roof. Recommend a licensed roofer to seal the nail heads.

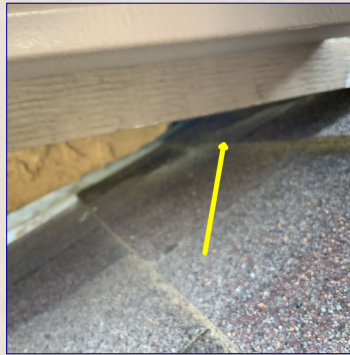
There were areas of missing flashing. Recommend a licensed roofer install flashing.

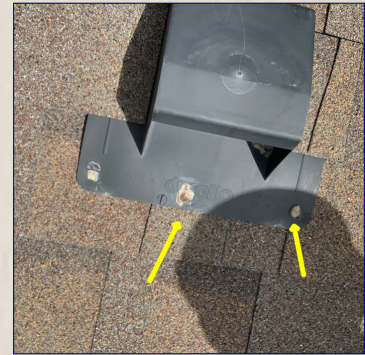
There are exposed nail heads securing the flashing to the roof. Exposed nail heads can allow water to penetrate the roof. Recommend a licensed roofer to seal the nail heads.

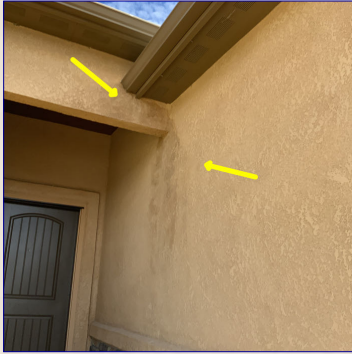
The stucco had moisture staining. Recommend a licensed contractor evaluate and repair as needed.

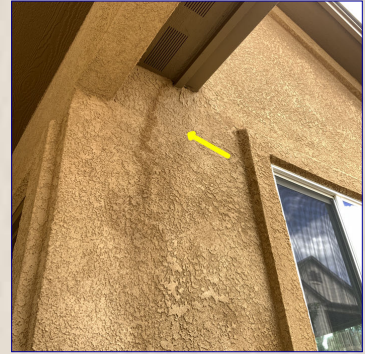
The stucco siding had moisture staining. Recommend a licensed contractor evaluate and repair as needed.

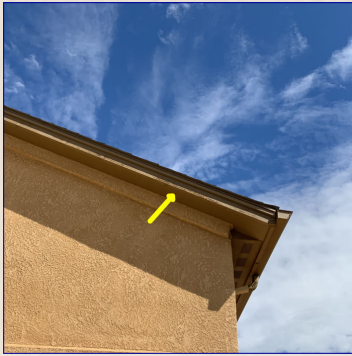
The fascia needs routine painting maintenance. Recommend a professional painter repair/paint the fascia.

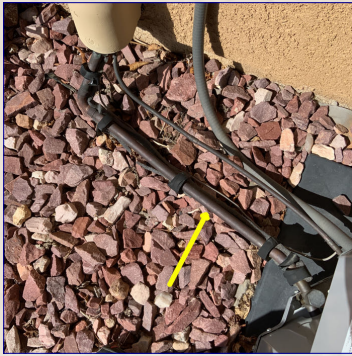
There is damaged and/or missing insulation on the air conditioner refrigerant line. Recommend replacing insulation.

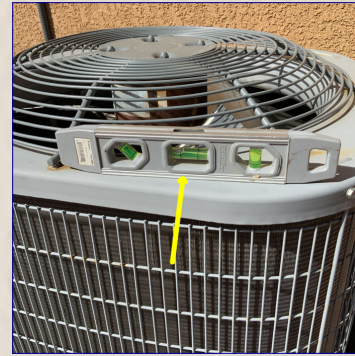
The air conditioner condensing unit is not level. Recommend a professional contractor to re-level the unit.

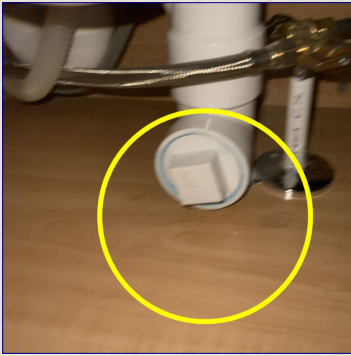
Page 28 Item: 4	Plumbing	<ul style="list-style-type: none"> <li>Drains in the kitchen are leaking, recommend a licensed plumber repair.</li> </ul>
-----------------	----------	---

Drains in the kitchen are leaking, recommend a licensed plumber repair.

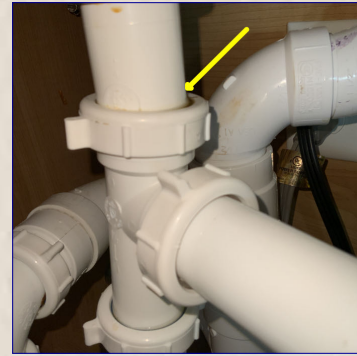
Drains in the kitchen are leaking, recommend a licensed plumber repair.

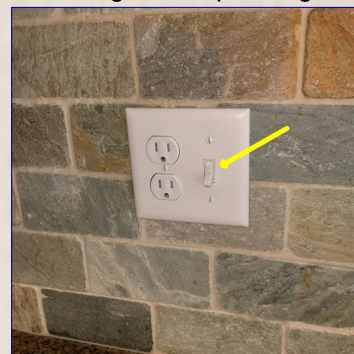
The switch did not appear to operate a fixture. Recommend contacting current owners as to purpose of switch. Contact a licensed electrician as needed.

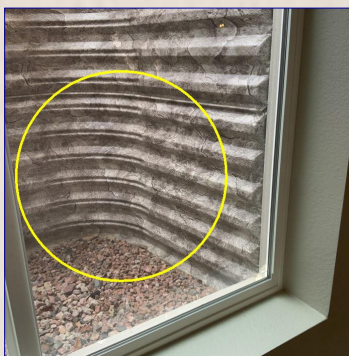
The screen was damaged. Recommend repairing as needed.

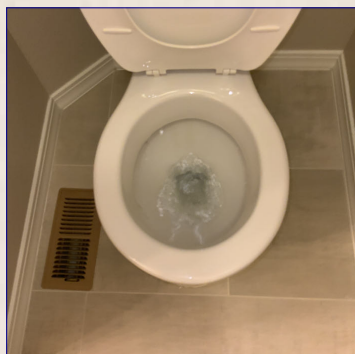
The toilet bowl is loose. Since movement of the toilet will damage the wax ring, recommend replacing the wax ring. While the toilet is removed verify the subfloor is still in good condition. Repair as needed.

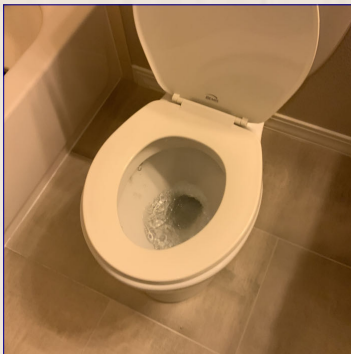
The toilet bowl is loose. Since movement of the toilet will damage the wax ring, recommend replacing the wax ring. While the toilet is removed verify the subfloor is still in good condition. Repair as needed.

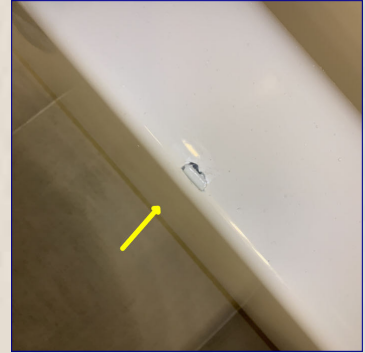
There are chips in the bathtub. Recommend sealing the chips to help prevent additional damage.

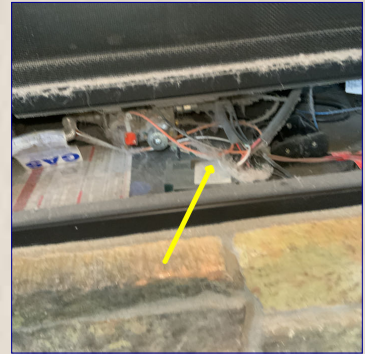
The fireplace compartment was dirty.  
Recommend cleaning compartment.

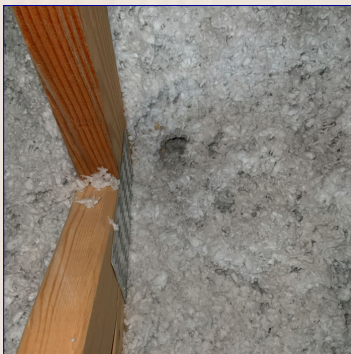
Page 54 Item: 10	Other	<ul style="list-style-type: none"> <li>• Pests are not part of the home inspection. However, there is evidence of rodents in the attic, which is a safety concern. Recommend a professional exterminator be consulted.</li> </ul>
------------------	-------	---

Pests are not part of the home inspection. However, there is evidence of rodents in the attic, which is a safety concern. Recommend a professional exterminator be consulted.

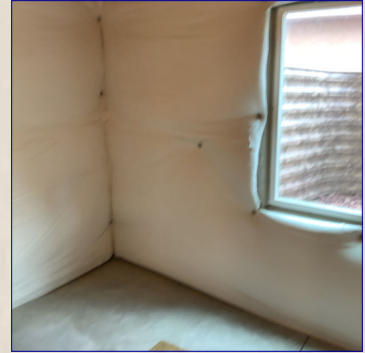
Foundation walls were covered with paneling/drywall/insulation/storage and were not visible. It is always possible that hidden damage may exist in non-visible areas. Consult a licensed contractor as needed.

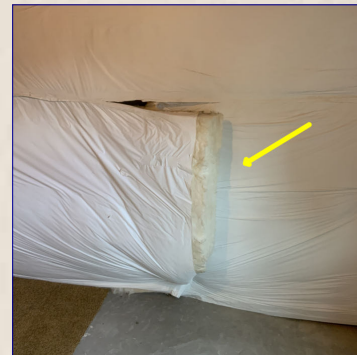
The insulation was displaced. Recommend repair as needed.

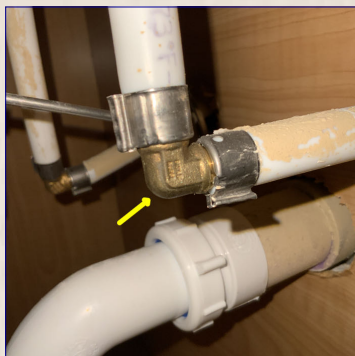
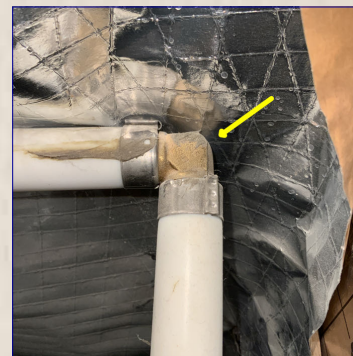
Page 59 Item: 5	Visible Water Distribution Piping	<ul style="list-style-type: none"> <li>Brass fittings were noticed on the PEX house plumbing that appears to be manufactured by Zurn or other manufacturers. These fittings have been known to fail and are part of a class-action lawsuit. The yellow brass fittings can be located at joints in the plastic pipe. Brass fittings are secured to the pipe by copper crimp rings or stainless steel clamps. The fittings were used for a variety of applications, including and without limitation, hot and cold water distribution in plumbing and radiant heating systems in homes, residences, buildings, or other structures. Most manufacturers stopped selling the brass fittings, in question, in 2010. We recommend, however, as part of making an investment decision in this house, that a licensed plumber familiar with the fittings referred to in the class action lawsuit evaluate and repair or replace the fittings as needed.</li> </ul>

Brass fittings were noticed on the PEX house plumbing that appears to be manufactured by Zurn or other manufacturers. These fittings have been known to fail and are part of a class-action lawsuit. The yellow brass fittings can be located at joints in the plastic pipe. Brass fittings are secured to the pipe by copper crimp rings or stainless steel clamps. The fittings were used for a variety of applications, including and without limitation, hot and cold water distribution in plumbing and radiant heating systems in homes, residences, buildings, or other structures. Most manufacturers stopped selling the brass fittings, in question, in 2010. We recommend, however, as part of making an investment decision in this house, that a licensed plumber familiar with the fittings referred to in the class action lawsuit evaluate and repair or replace the fittings as needed.

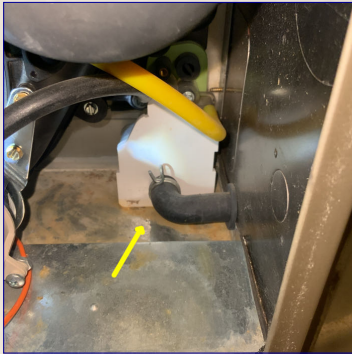
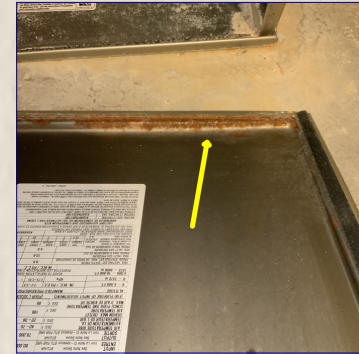
The furnace showed signs of rust and corrosion. Recommend a professional HVAC technician evaluate and repair as needed.
