Home Inspection Report

Inspection Address: 288 Sunny Way

Inspector: Joe Gardino

Inspection Date: 2022/9/15

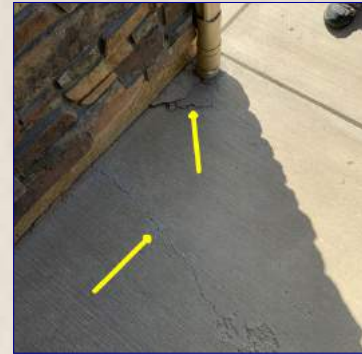
There is spalling on the service walks. Spalling is a common surface imperfection. In most cases, the defect does not affect the slab's service life if untreated. Recommend a professional contractor repair to help prevent additional damage as needed.

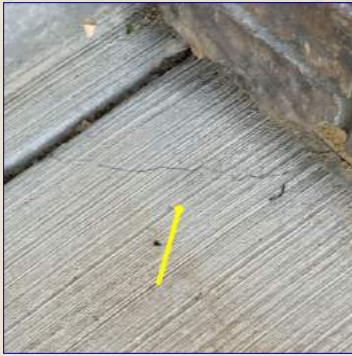
The walkway had some typical cracking/chipping but is usable. Recommend a professional contractor seal the cracks to help prevent additional damage.

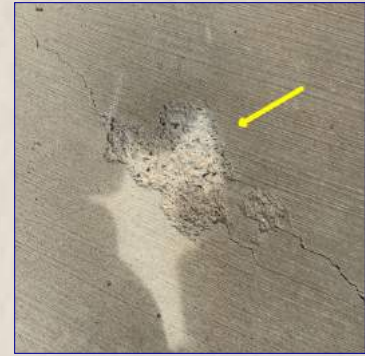
There is spalling on the service walks. Spalling is a common surface imperfection. In most cases, the defect does not affect the slab's service life if untreated. Recommend a professional contractor repair to help prevent additional damage as needed.

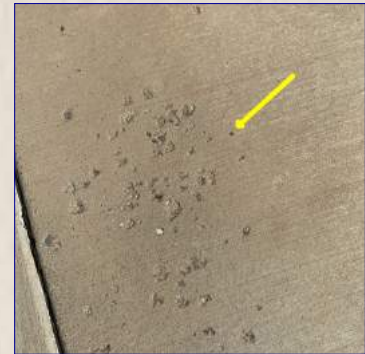
The driveway has areas of spalling. Spalling is a common surface imperfection. In most cases, the defect does not affect the slab's service life if untreated. Recommend a professional contractor repair to help prevent additional damage.

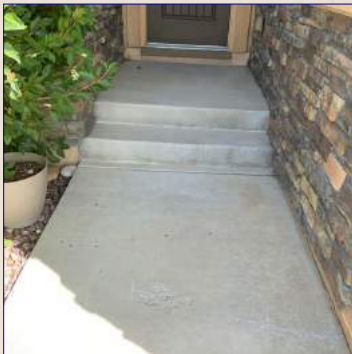
There is a crack at the steps. Recommend a professional contractor seal the crack to help prevent additional damage to the concrete.

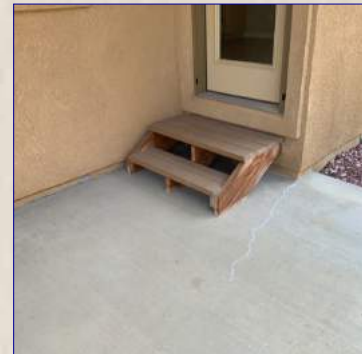
There are open risers on the exterior wood stairs, which is a potential safety concern. Recommend using additional caution in these areas. Install proper risers for added safety.

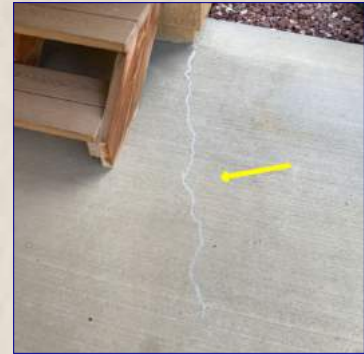
The patio has typical cracks. Recommend a professional contractor seal the cracks to help protect the cement from damage.

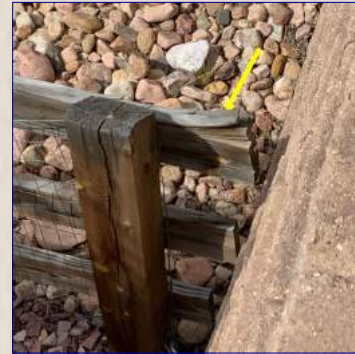
The fence has some damage. Recommend monitoring and consulting with a professional contractor for regular maintenance repairs as needed.

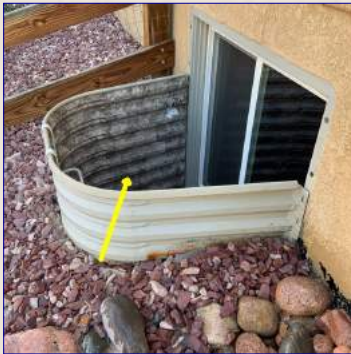
Window well covers are missing in one or more locations. Adding window well covers will help prevent moisture and debris from entering the window wells. In addition, an open window well is a falling hazard. Recommend adding window well covers.

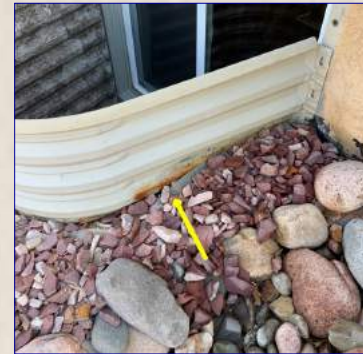
The window well had some rusting. Recommend monitoring and contacting a licensed contractor as needed.

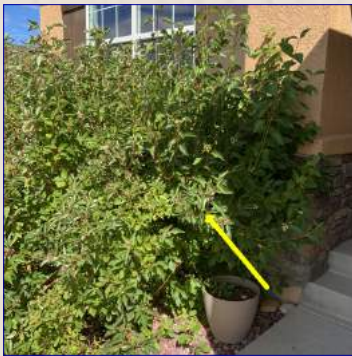
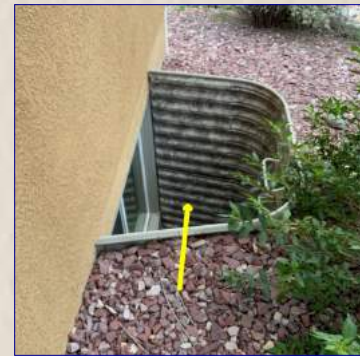
There is vegetation in contact with the house. Recommend trimming trees/vegetation, so it doesn't come into contact with the home.

Window well covers are missing in one or more locations. Adding window well covers will help prevent moisture and debris from entering the window wells. In addition, an open window well is a falling hazard. Recommend adding window well covers.

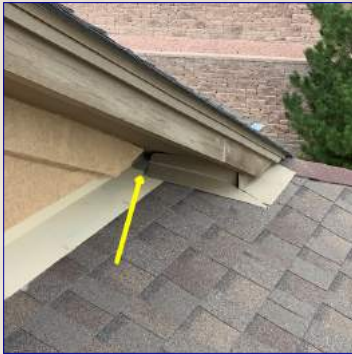
There were gaps at the flashing. Recommend a licensed roofer evaluate repair as needed.

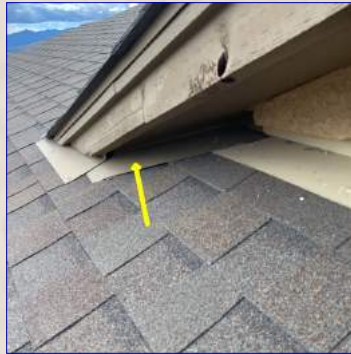
There were gaps at the flashing. Recommend a licensed roofer evaluate repair as needed.

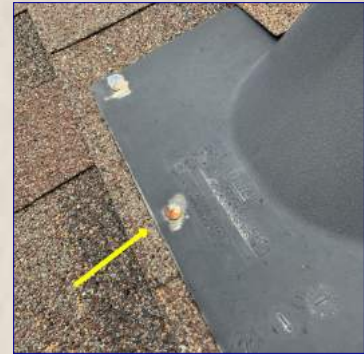
There are exposed nail heads securing the flashing to the roof. Exposed nail heads can allow water to penetrate the roof. Recommend a licensed roofer to seal the nail heads.

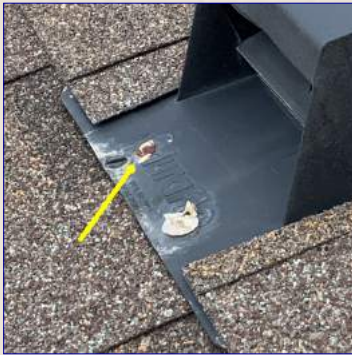
There are exposed nail heads securing the flashing to the roof. Exposed nail heads can allow water to penetrate the roof. Recommend a licensed roofer to seal the nail heads.

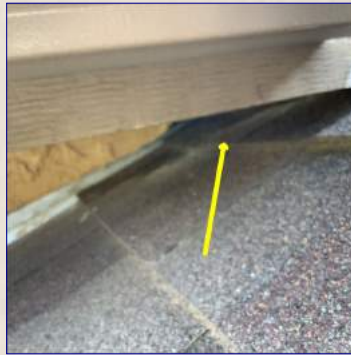
There were areas of missing flashing. Recommend a licensed roofer install flashing.

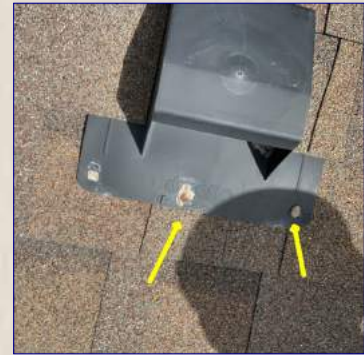
There are exposed nail heads securing the flashing to the roof. Exposed nail heads can allow water to penetrate the roof. Recommend a licensed roofer to seal the nail heads.

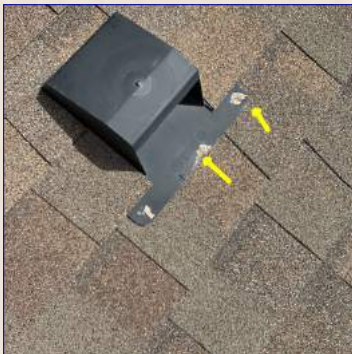
There are exposed nail heads securing the flashing to the roof. Exposed nail heads can allow water to penetrate the roof. Recommend a licensed roofer to seal the nail heads.

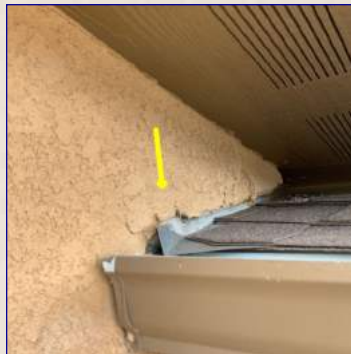
Kick Out flashing is missing at one or more locations, which may allow moisture damage on the home's exterior, walkways, and driveways. Recommend a licensed contractor install flashing to help properly move water to the gutter system. Repair damaged areas as needed.

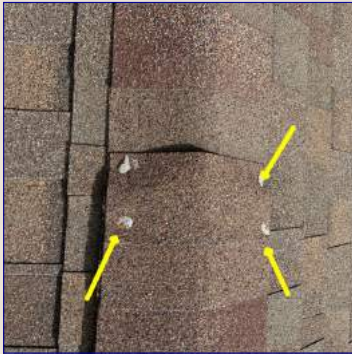
There are exposed nail heads on the roof. Exposed nail heads may allow water to seep through and damage the sheathing over time. Recommend a licensed roofer caulk the exposed nail heads.

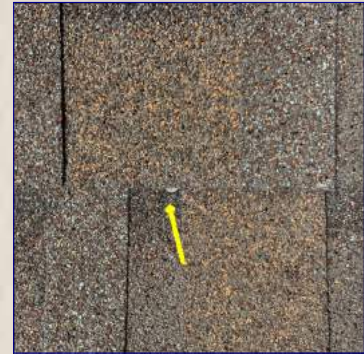
There are exposed nail heads on the roof. Exposed nail heads may allow water to seep through and damage the sheathing over time. Recommend a licensed roofer caulk the exposed nail heads.

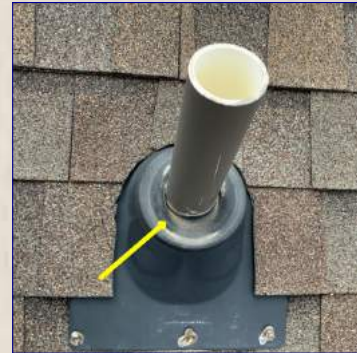
One or more plumbing vent flashing was sunken, which can allow water/ice build-up and cause premature failure and leaking of the plumbing vent. Recommend a professional roofing contractor repair or replace the roof pipe flashing.

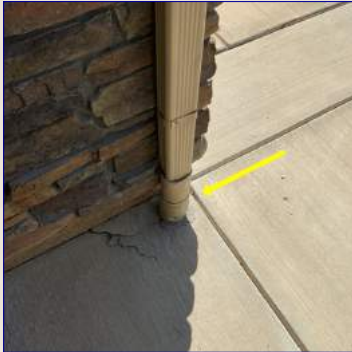
The gutter termination point was not visible. There is always the potential for hidden damage in non visible areas. Recommend monitoring and contacting a licensed contractor as needed.

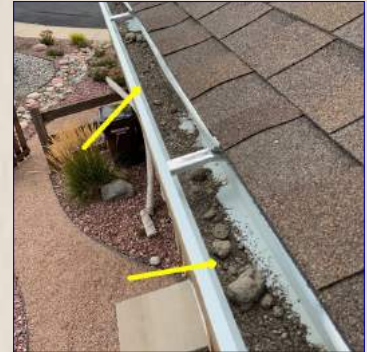
The gutters are dirty. Recommend cleaning the gutters to ensure proper water flow to the downspouts.

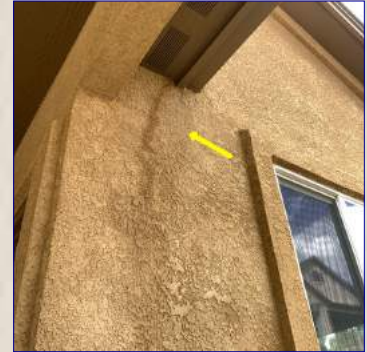
The stucco siding had moisture staining. Recommend a licensed contractor evaluate and repair as needed.

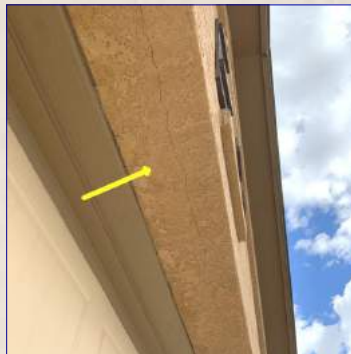
The stucco siding had typical cracking present in one or more areas. Monitor and repair as needed.

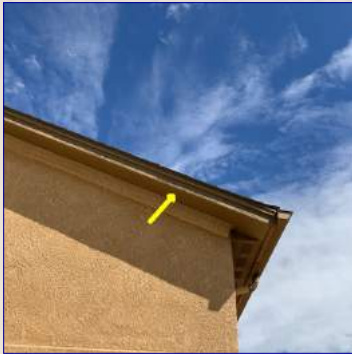
The fascia needs routine painting maintenance. Recommend a professional painter repair/paint the fascia.

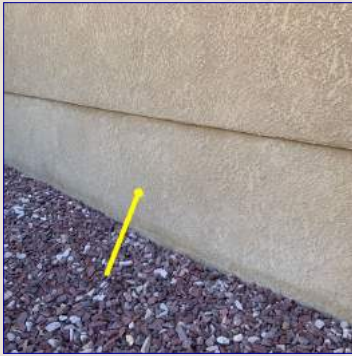
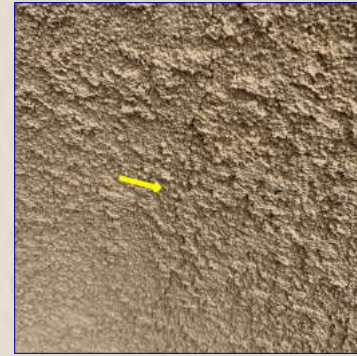
One or more areas of the foundation wall(s) have limited or no visibility due to foundation paint. No evaluation can be made. Recommend monitoring and consulting a licensed contractor as needed.

There are expected vertical cracks in the foundation. All cracks have a potential for leaking and for future potential movement, which can not be predicted. Recommend sealing and monitoring. Consult a licensed foundation expert if any cracks start leaking or become active.

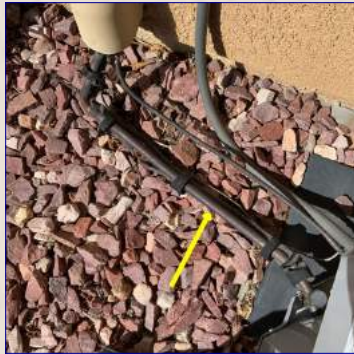
There is damaged and/or missing insulation on the air conditioner refrigerant line. Recommend replacing insulation.

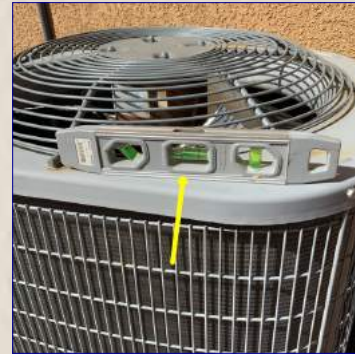
The air conditioner condensing unit is not level. Recommend a professional contractor to re-level the unit.

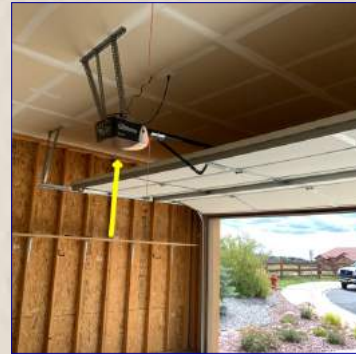
Page 24 Item: 2	Automatic Opener	<ul style="list-style-type: none"> The automatic garage door opener was not working properly. Recommend a professional contractor evaluate and repair or replace as needed.
-----------------	------------------	--

The automatic garage door opener was not working properly. Recommend a professional contractor evaluate and repair or replace as needed.

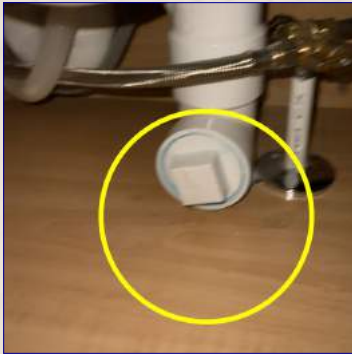
Page 28 Item: 4	Plumbing	<ul style="list-style-type: none"> Drains in the kitchen are leaking, recommend a licensed plumber repair.
-----------------	----------	---

Drains in the kitchen are leaking, recommend a licensed plumber repair.

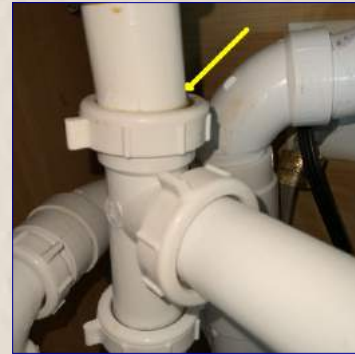
Drains in the kitchen are leaking, recommend a licensed plumber repair.

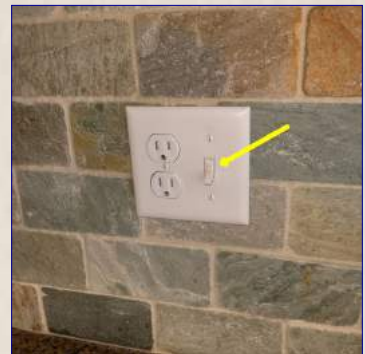
The switch did not appear to operate a fixture. Recommend contacting current owners as to purpose of switch. Contact a licensed electrician as needed.

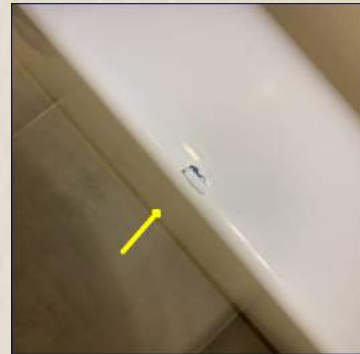
There are chips in the bathtub. Recommend sealing the chips to help prevent additional damage.

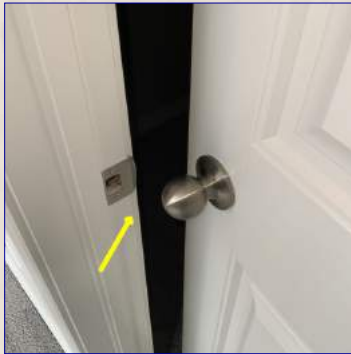
The door does not latch. Recommend repairing as needed.

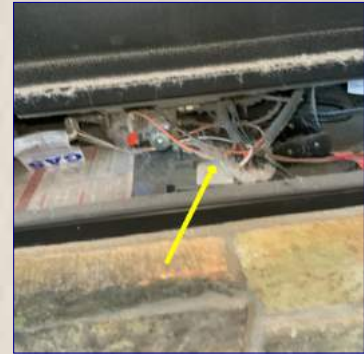
The fireplace compartment was dirty. Recommend cleaning compartment.

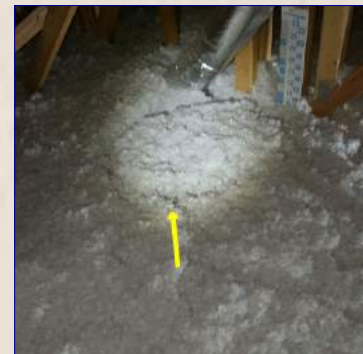
Pests are not part of the home inspection. However, there is evidence of rodents in the attic, which is a safety concern. Recommend a professional exterminator be consulted.

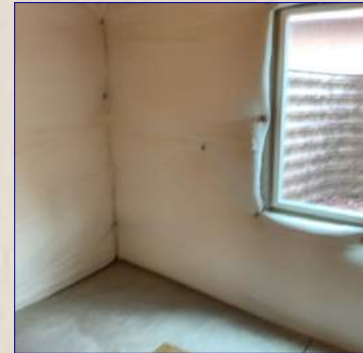
Foundation walls were covered with paneling/drywall/insulation/storage and were not visible. It is always possible that hidden damage may exist in non-visible areas. Consult a licensed contractor as needed.

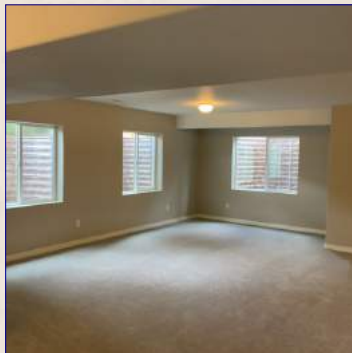
Foundation walls were covered with paneling/drywall/insulation/storage and were not visible. It is always possible that hidden damage may exist in non-visible areas. Consult a licensed contractor as needed.

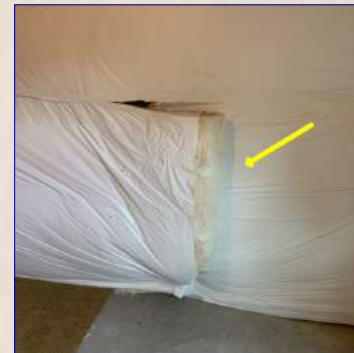
The insulation was displaced. Recommend repair as needed.

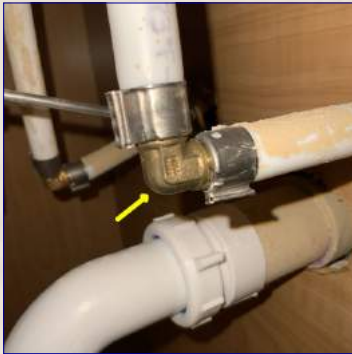
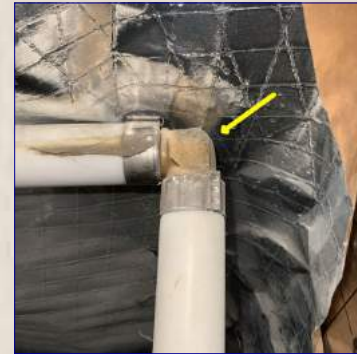
Page 59 Item: 5	Visible Water Distribution Piping	<ul style="list-style-type: none"> Brass fittings were noticed on the PEX house plumbing that appears to be manufactured by Zurn or other manufacturers. These fittings have been known to fail and are part of a class-action lawsuit. The yellow brass fittings can be located at joints in the plastic pipe. Brass fittings are secured to the pipe by copper crimp rings or stainless steel clamps. The fittings were used for a variety of applications, including and without limitation, hot and cold water distribution in plumbing and radiant heating systems in homes, residences, buildings, or other structures. Most manufacturers stopped selling the brass fittings, in question, in 2010. We recommend, however, as part of making an investment decision in this house, that a licensed plumber familiar with the fittings referred to in the class action lawsuit evaluate and repair or replace the fittings as needed.

Brass fittings were noticed on the PEX house plumbing that appears to be manufactured by Zurn or other manufacturers. These fittings have been known to fail and are part of a class-action lawsuit. The yellow brass fittings can be located at joints in the plastic pipe. Brass fittings are secured to the pipe by copper crimp rings or stainless steel clamps. The fittings were used for a variety of applications, including and without limitation, hot and cold water distribution in plumbing and radiant heating systems in homes, residences, buildings, or other structures. Most manufacturers stopped selling the brass fittings, in question, in 2010. We recommend, however, as part of making an investment decision in this house, that a licensed plumber familiar with the fittings referred to in the class action lawsuit evaluate and repair or replace the fittings as needed.

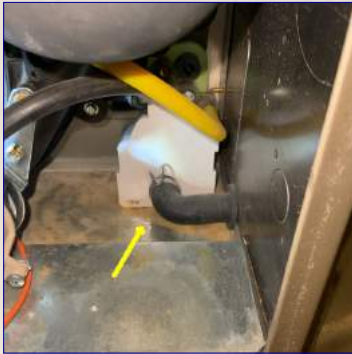
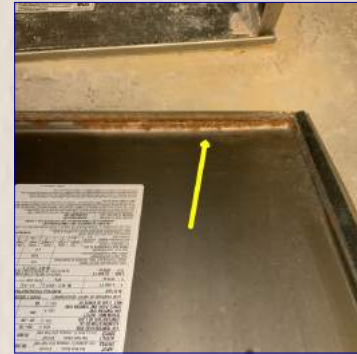
The furnace showed signs of rust and corrosion. Recommend a professional HVAC technician evaluate and repair as needed.
