# HOME INSPECTION REPORT

**Inspection Address: 288 Sunny Way**

**Inspection Date: 2022/9/15**

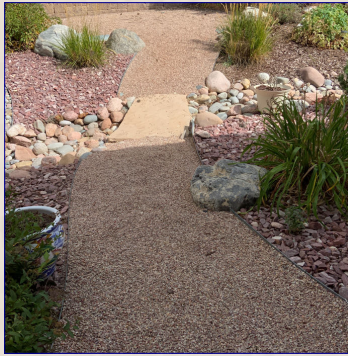
The Service Walk View

There is spalling on the service walks. Spalling is a common surface imperfection. In most cases, the defect does not affect the slab's service life if untreated. Recommend a professional contractor repair to help prevent additional damage as needed.

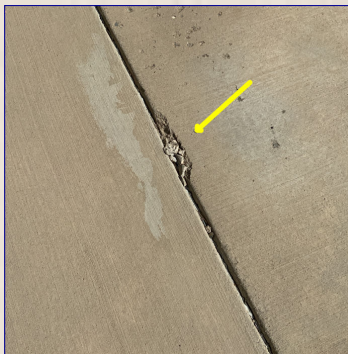
The driveway has areas of spalling. Spalling is a common surface imperfection. In most cases, the defect does not affect the slab's service life if untreated. Recommend a professional contractor repair to help prevent additional damage.

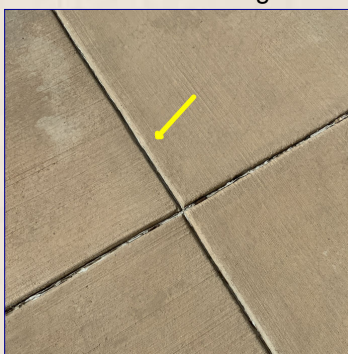
The driveway is cracked. Recommend sealing the cracks to help prevent additional damage. Consult a professional contractor as needed.

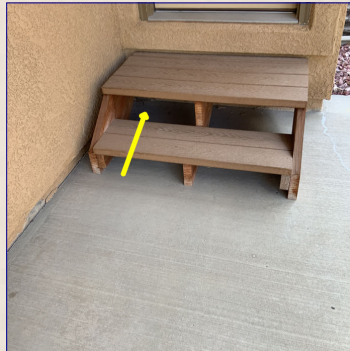
- There are open risers on the exterior wood stairs, which is a potential safety concern. Recommend using additional caution in these areas. Install proper risers for added safety.

There are open risers on the exterior wood stairs, which is a potential safety concern. Recommend using additional caution in these areas. Install proper risers for added safety.

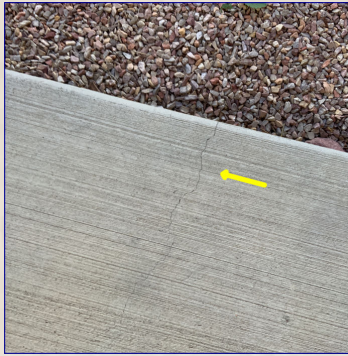
The patio has typical cracks. Recommend a professional contractor seal the cracks to help protect the cement from damage.

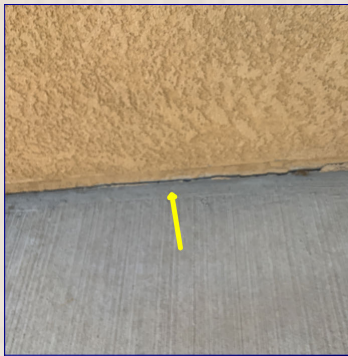
There is a gap between the patio and the house. Recommend sealing the gap between the patio and the house to help prevent water penetration.

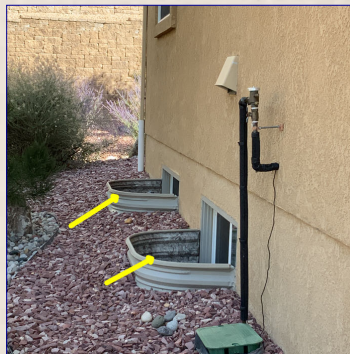
Window well covers are missing in one or more locations. Adding window well covers will help prevent moisture and debris from entering the window wells. In addition, an open window well is a falling hazard. Recommend adding window well covers.

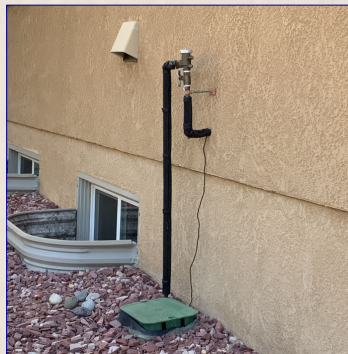
The lawn sprinkler system is not within the scope of the home inspection. Recommend an irrigation/landscape company evaluation before use.

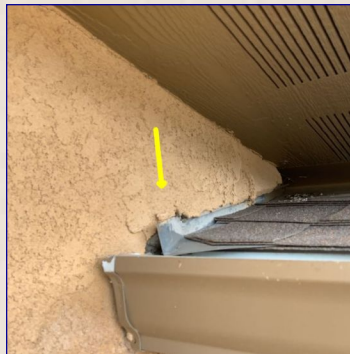
- Kick Out flashing is missing at one or more locations, which may allow moisture damage on the home's exterior, walkways, and driveways. Recommend a licensed contractor install flashing to help properly move water to the gutter system. Repair damaged areas as needed.

Kick Out flashing is missing at one or more locations, which may allow moisture damage on the home's exterior, walkways, and driveways. Recommend a licensed contractor install flashing to help properly move water to the gutter system. Repair damaged areas as needed.

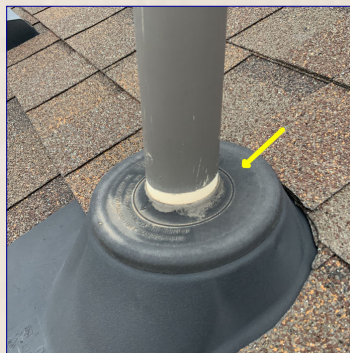
One or more plumbing vent flashing was sunken, which can allow water/ice build-up and cause premature failure and leaking of the plumbing vent. Recommend a professional roofing contractor repair or replace the roof pipe flashing.

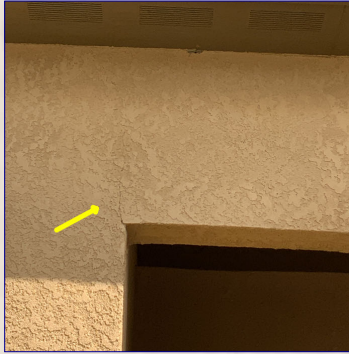
The stucco siding had typical cracking present in one or more areas. Monitor and repair as needed.

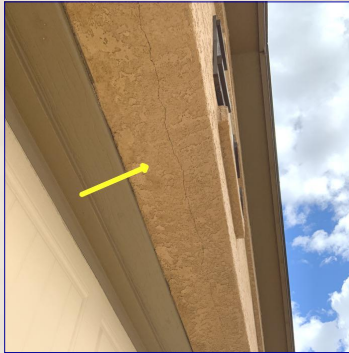
The stucco siding had typical cracking present in one or more areas. Monitor and repair as needed.

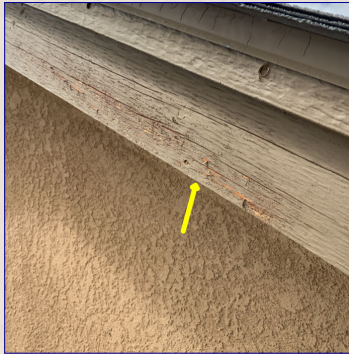
The fascia needs routine painting maintenance. Recommend a professional painter repair/paint the fascia.

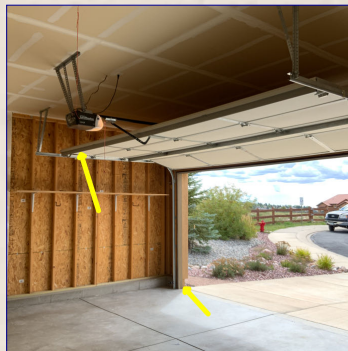
The safety devices on the large garage door cannot be tested due to the door not operating properly. Recommend a licensed contractor repair and re-test safety features on garage door.

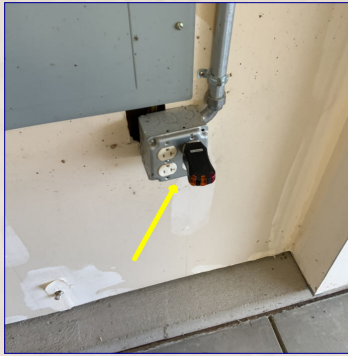
Not all of the electrical outlets are GFCI's installed in the garage, which is a safety concern. Recommend a licensed electrician install GFCI receptacles.

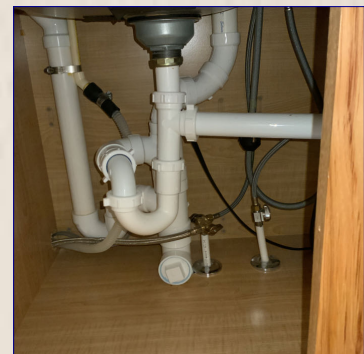
Kitchen plumbing view

Drains in the kitchen are leaking, recommend a licensed plumber repair.

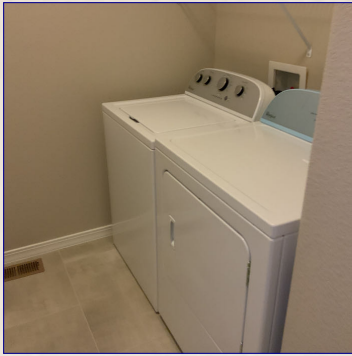
The washer and dryer are excluded from the inspection as they can not be properly tested. Any comments are made for courtesy purposes only.

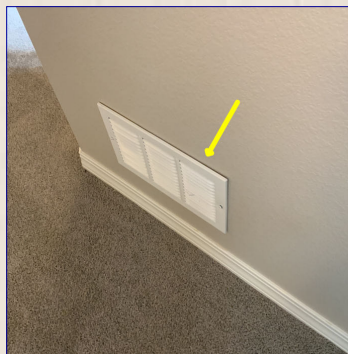
The heating vent has become damaged/detached from the wall. Recommend a professional contractor repair as needed.

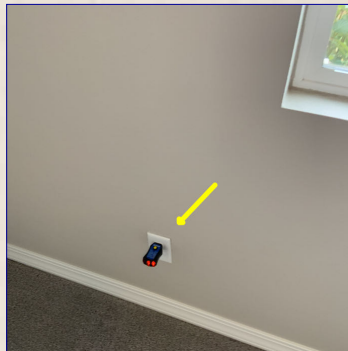
There are loose receptacles present in the room, which is a potential safety concern. Recommend a licensed electrician repair.

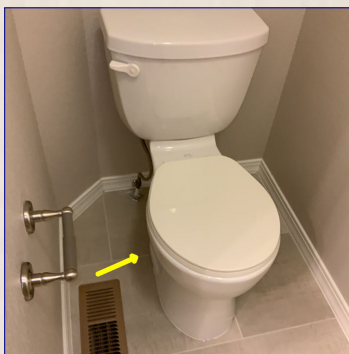
The toilet bowl is loose. Since movement of the toilet will damage the wax ring, recommend replacing the wax ring. While the toilet is removed verify the subfloor is still in good condition. Repair as needed.

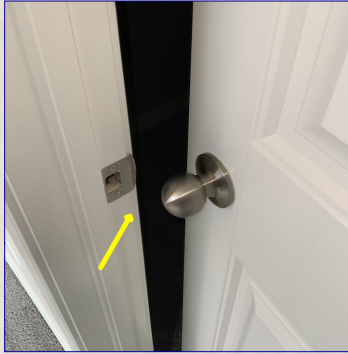
The door does not latch. Recommend repairing as needed.

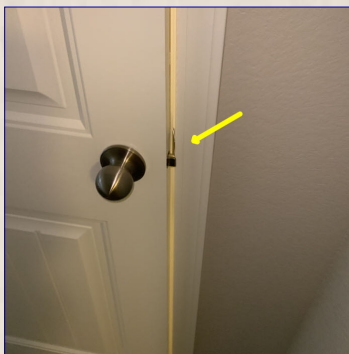
The door does not latch. Recommend repairing as needed.

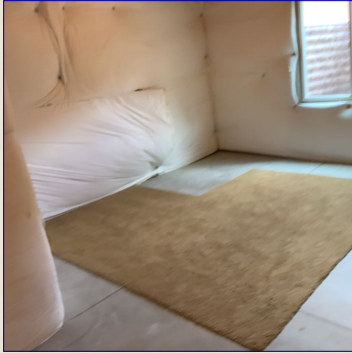
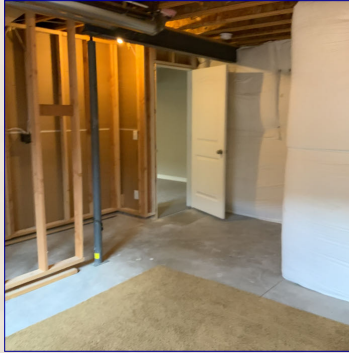
Foundation walls were covered with paneling/drywall/insulation/storage and were not visible. It is always possible that hidden damage may exist in non-visible areas. Consult a licensed contractor as needed.

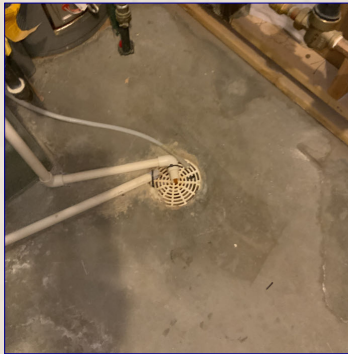
The floor drain, as seen in the basement, was not tested. Recommend pouring water into the drain periodically to help prevent sewer gases from backing up into the home.

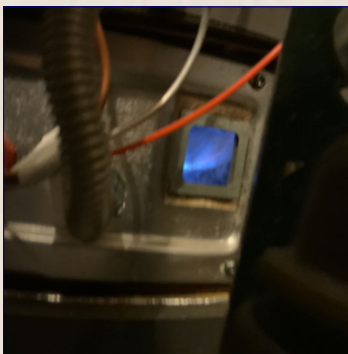
The water heater operating.

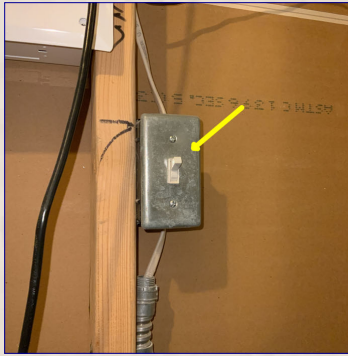
The electrical shutoff switch.

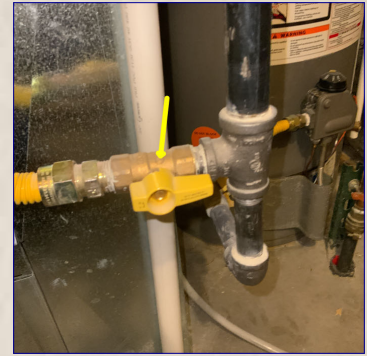
The gas shutoff valve.

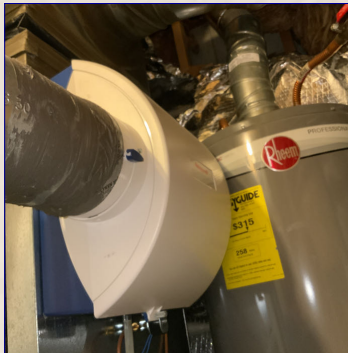
Humidifiers are not part of the home inspection. Recommend normal maintenance per the manufacturers specifications. Consult a licensed HVAC contractor as needed.

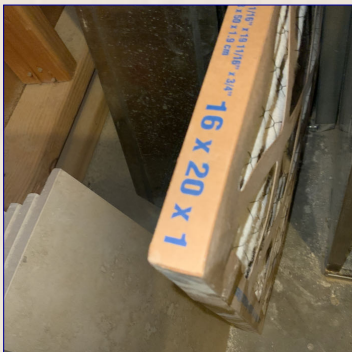
Furnace filter size

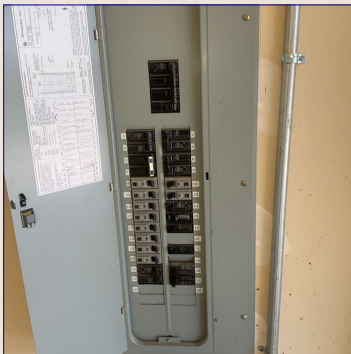
The main electrical service panel.

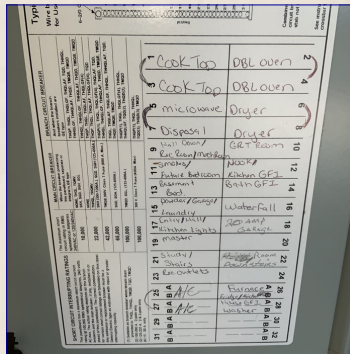
The main electrical service panel legend.

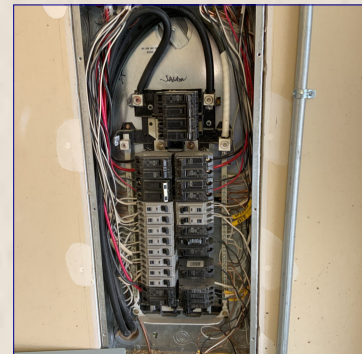
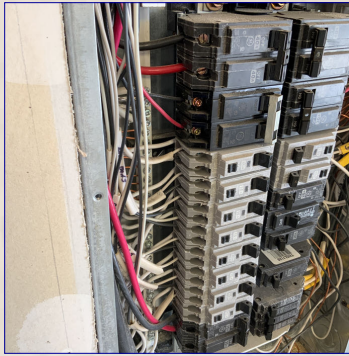
The main electrical service panel-cover removed.

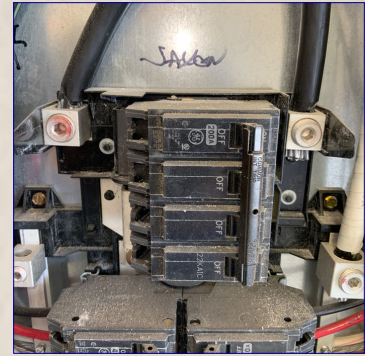
The main electrical service panel shut off breaker.
