Home Inspection Report

Inspection Address: 288 Sunny Way

Inspector: Joe Gardino

Inspection Date: 2022/9/15

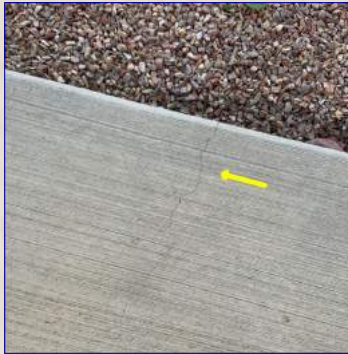
The patio has typical cracks. Recommend a professional contractor seal the cracks to help protect the cement from damage.

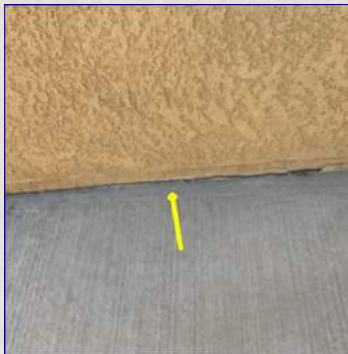
There is a gap between the patio and the house. Recommend sealing the gap between the patio and the house to help prevent water penetration.

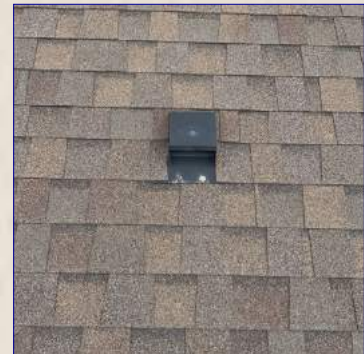
One or more plumbing vent flashing was sunken, which can allow water/ice build-up and cause premature failure and leaking of the plumbing vent. Recommend a professional roofing contractor repair or replace the roof pipe flashing.

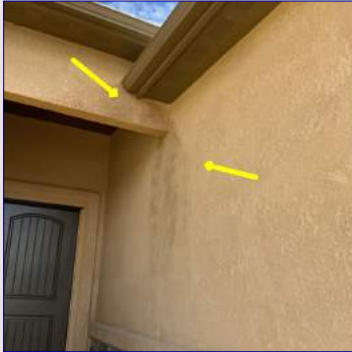
The stucco had moisture staining. Recommend a licensed contractor evaluate and repair as needed.

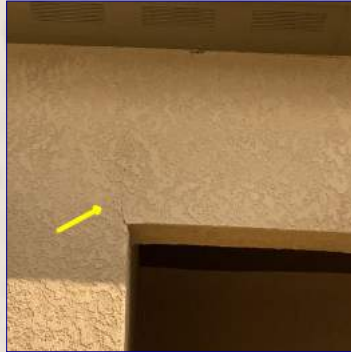
The stucco siding had typical cracking present in one or more areas. Monitor and repair as needed.

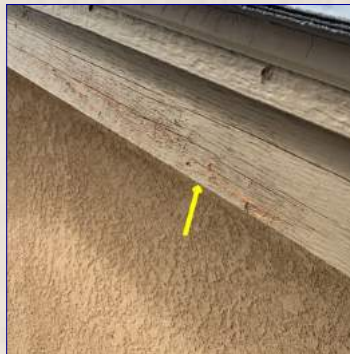
The fascia needs routine painting maintenance. Recommend a professional painter repair/paint the fascia.

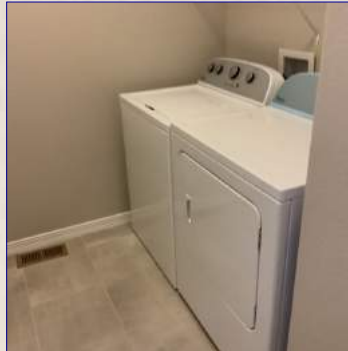
The Laundry Room

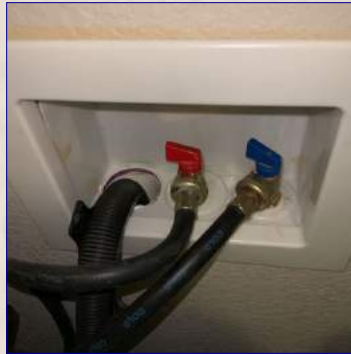
Laundry, washer hook-up view

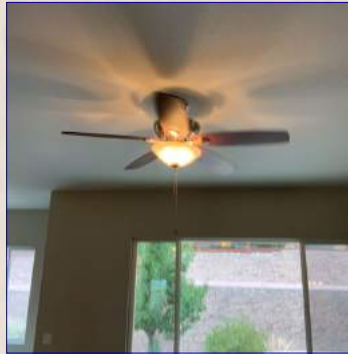
Ceiling fan operating

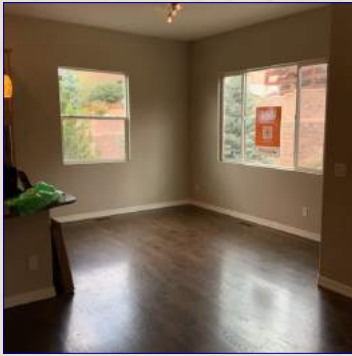
The Dining Room View

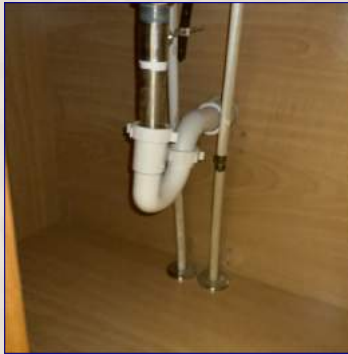
The bathroom plumbing view.

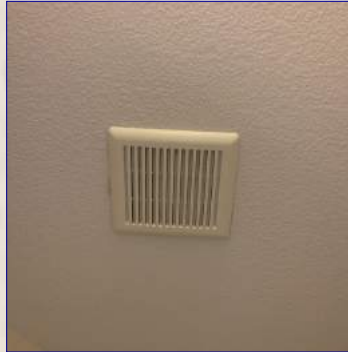
The exhaust fan operating.

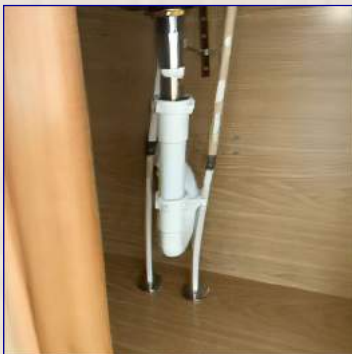
The bathroom plumbing view.

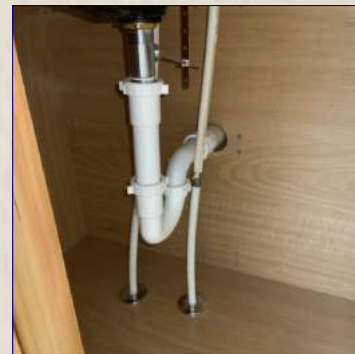
The bathroom plumbing view.

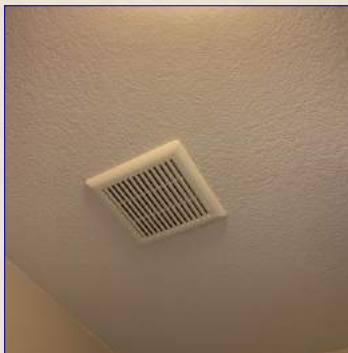
The exhaust fan operating.

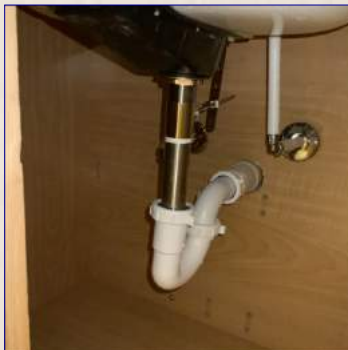
The bathroom plumbing view.
