Home Inspection Report

Inspection Address: 288 Sunny Way

Inspector: Joe Gardino

Inspection Date: 2022/9/15

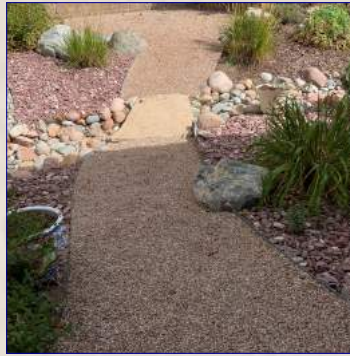
The Service Walk View

There is spalling on the service walks. Spalling is a common surface imperfection. In most cases, the defect does not affect the slab's service life if untreated. Recommend a professional contractor repair to help prevent additional damage as needed.

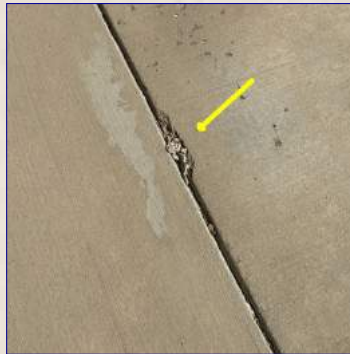
The driveway has areas of spalling. Spalling is a common surface imperfection. In most cases, the defect does not affect the slab's service life if untreated. Recommend a professional contractor repair to help prevent additional damage.

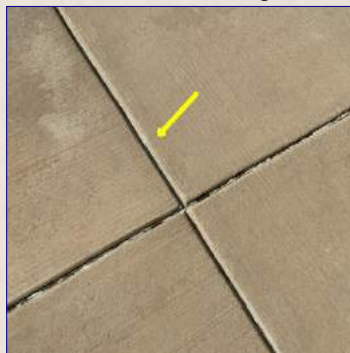
The driveway is cracked. Recommend sealing the cracks to help prevent additional damage. Consult a professional contractor as needed.

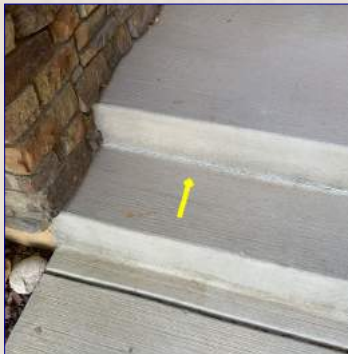
There is a crack at the steps. Recommend a professional contractor seal the crack to help prevent additional damage to the concrete.

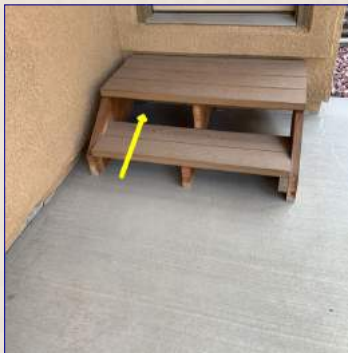
Page 9 Item: 4	Steps/Stoop	<ul style="list-style-type: none"> There are open risers on the exterior wood stairs, which is a potential safety concern. Recommend using additional caution in these areas. Install proper risers for added safety.
----------------	-------------	--

There are open risers on the exterior wood stairs, which is a potential safety concern. Recommend using additional caution in these areas. Install proper risers for added safety.

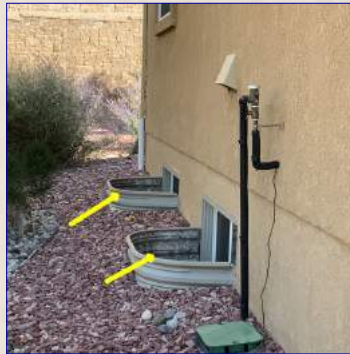
Window well covers are missing in one or more locations. Adding window well covers will help prevent moisture and debris from entering the window wells. In addition, an open window well is a falling hazard. Recommend adding window well covers.

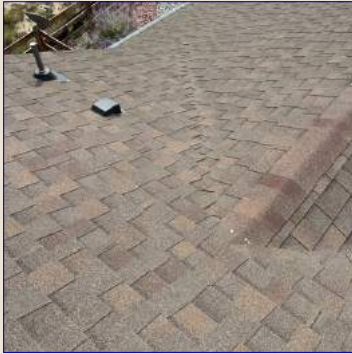
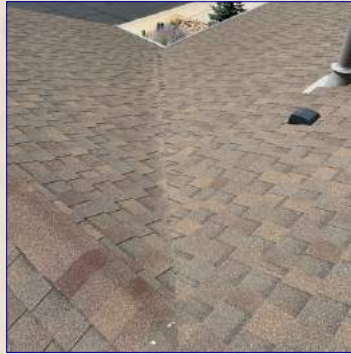
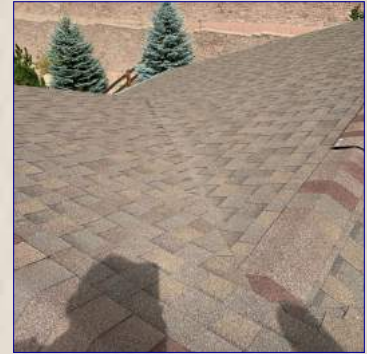
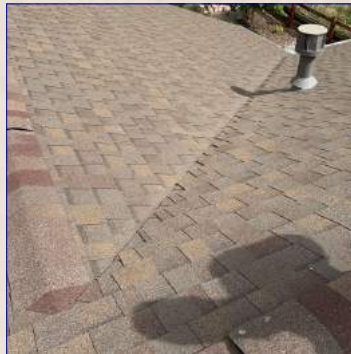
The Valley

The roof **valleys** inspection is limited to the visual portion of the valleys. There is always the potential for hidden damage in non visible areas. Recommend monitoring and consulting a licensed roofer as needed.

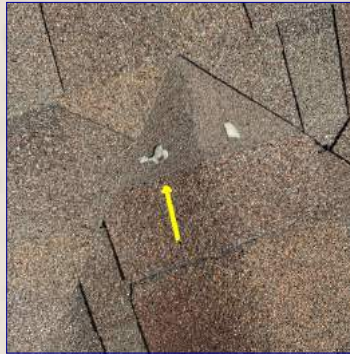
There are exposed nail heads on the roof. Exposed nail heads may allow water to seep through and damage the sheathing over time. Recommend a licensed roofer caulk the exposed nail heads.

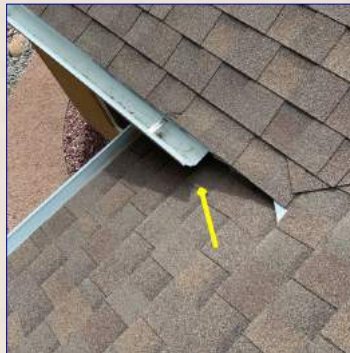
Gutters terminate on roof surfaces, which is a common practice but will concentrate a large amount of water on one location of asphalt shingles. This will allow more wear in one location. Recommend redirecting the water discharge to other gutters or to the ground.

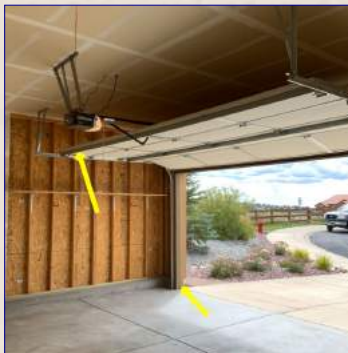
The safety devices on the large garage door cannot be tested due to the door not operating properly. Recommend a licensed contractor repair and re-test safety features on garage door.

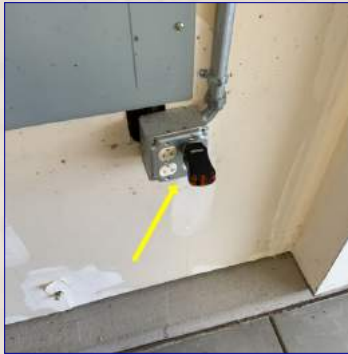
Not all of the electrical outlets are GFCI's installed in the garage, which is a safety concern. Recommend a licensed electrician install GFCI receptacles.

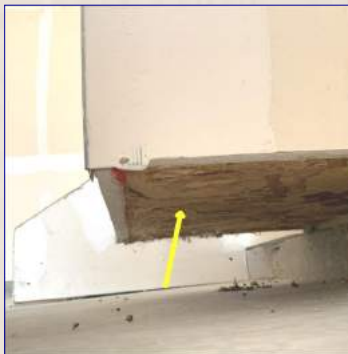
The firewall between the garage and living area is not present in spots - Potential Safety Hazard. Recommend a licensed contractor install a firewall.

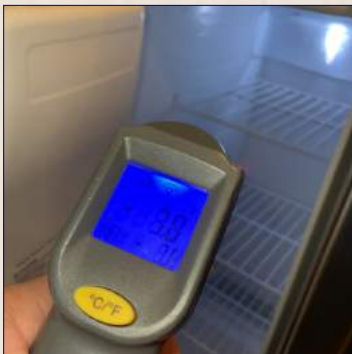
Freezer operating.

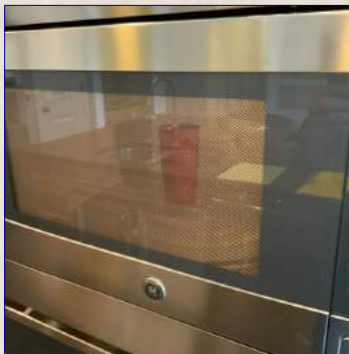
Microwave operating.

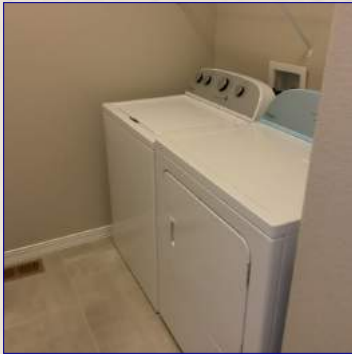
The washer and dryer are excluded from the inspection as they can not be properly tested. Any comments are made for courtesy purposes only.

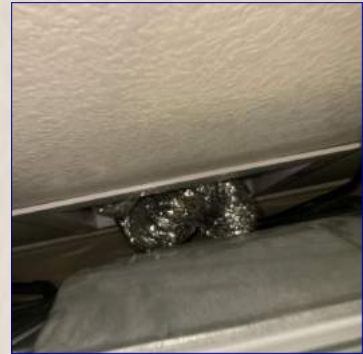
The dryer hook-up view.

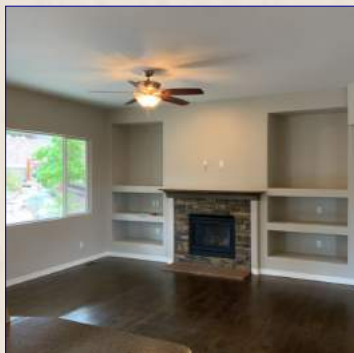
The Living Room View

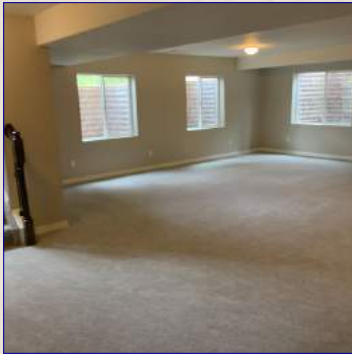
The Family Room View

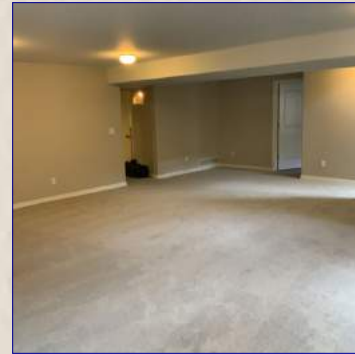
The Family Room View

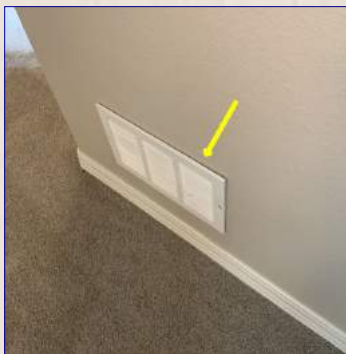
The heating vent has become damaged/detached from the wall. Recommend a professional contractor repair as needed.

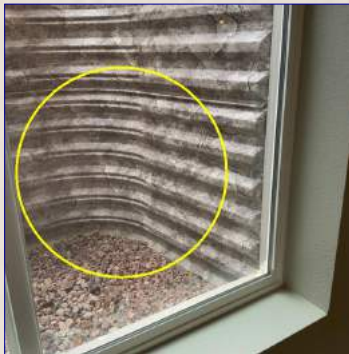
The screen was damaged. Recommend repairing as needed.

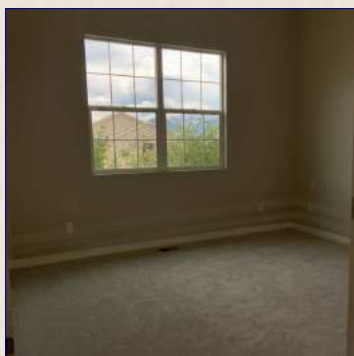
The Office View

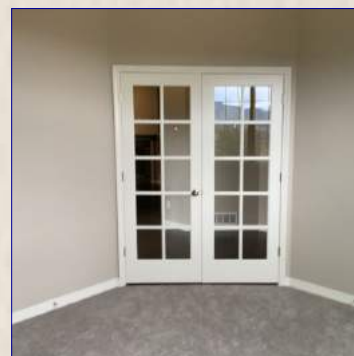
The Office View

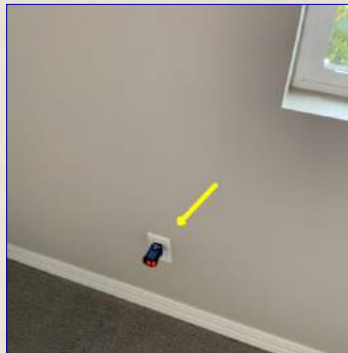
- There are loose receptacles present in the room, which is a potential safety concern. Recommend a licensed electrician repair.

There are loose receptacles present in the room, which is a potential safety concern. Recommend a licensed electrician repair.

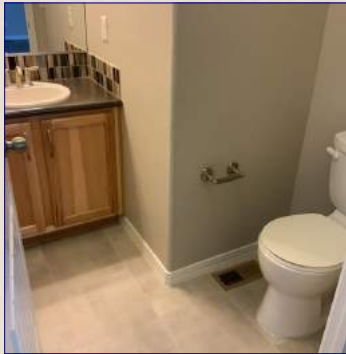
Bathroom 1 View

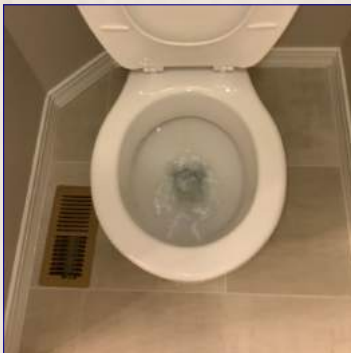
Toilet operating

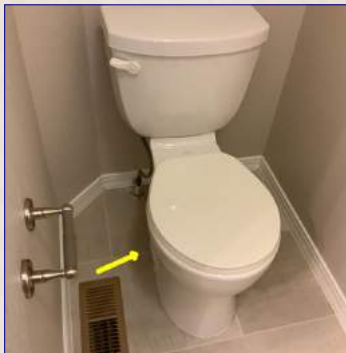
The toilet bowl is loose. Since movement of the toilet will damage the wax ring, recommend replacing the wax ring. While the toilet is removed verify the subfloor is still in good condition. Repair as needed.

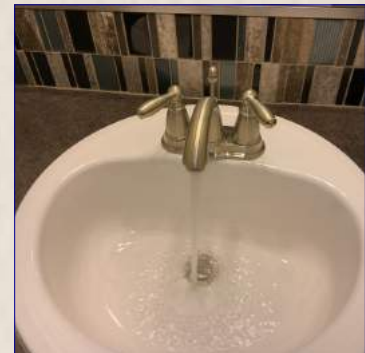
Sink faucet operating

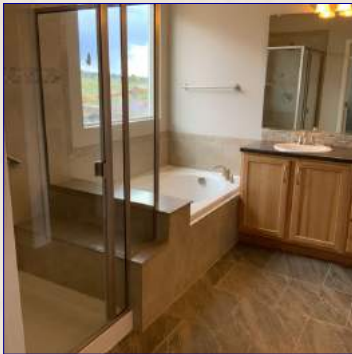
Bathroom 2 View

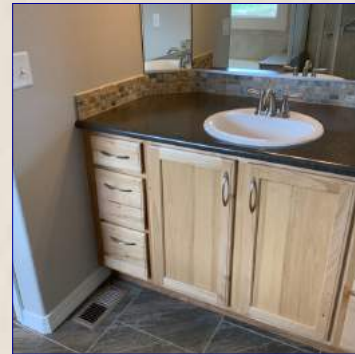
Bathroom 2 View

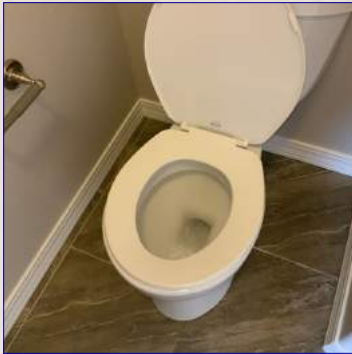
Toilet operating

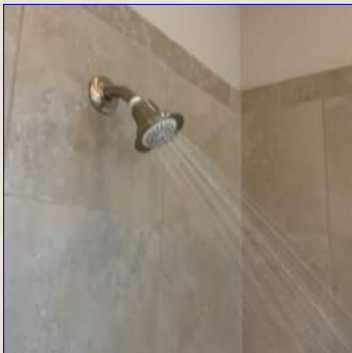
Shower operating

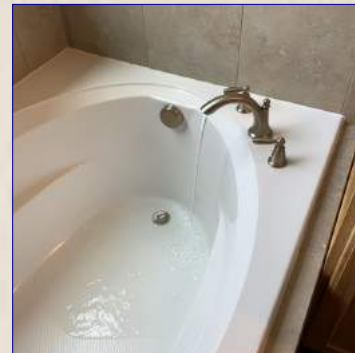
Bathtub operating

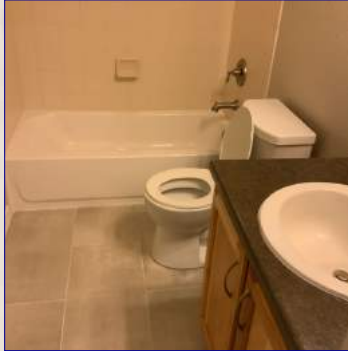
Bathroom 3 View

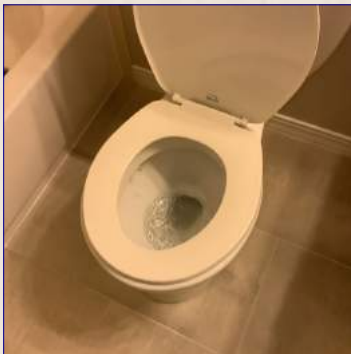
Toilet operating

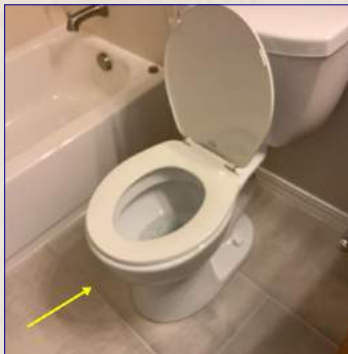
The toilet bowl is loose. Since movement of the toilet will damage the wax ring, recommend replacing the wax ring. While the toilet is removed verify the subfloor is still in good condition. Repair as needed.

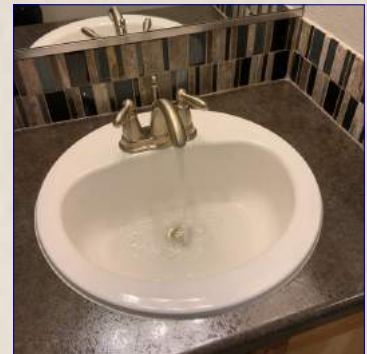
Sink faucet operating

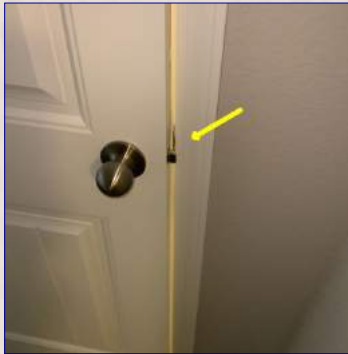
The door does not latch. Recommend repairing as needed.

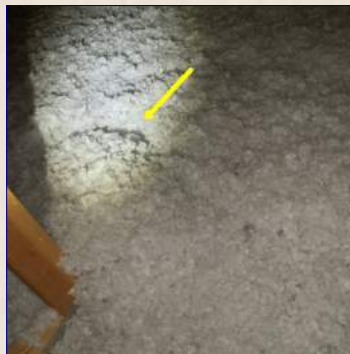
Pests are not part of the home inspection. However, there is evidence of rodents in the attic, which is a safety concern. Recommend a professional exterminator be consulted.

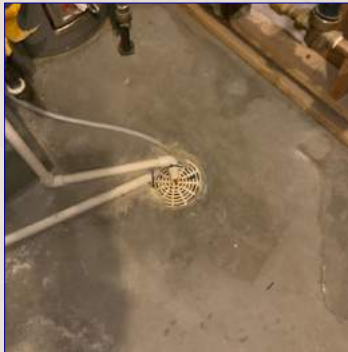
The floor drain, as seen in the basement, was not tested. Recommend pouring water into the drain periodically to help prevent sewer gases from backing up into the home.

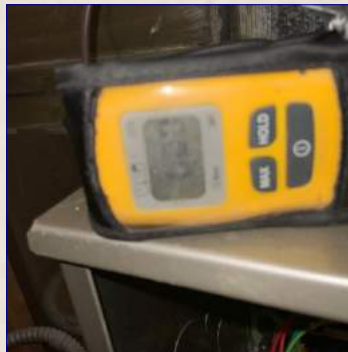
No carbon monoxide was detected. Recommend regular monitoring with proper carbon monoxide detectors. Consult a licensed HVAC technician as needed.

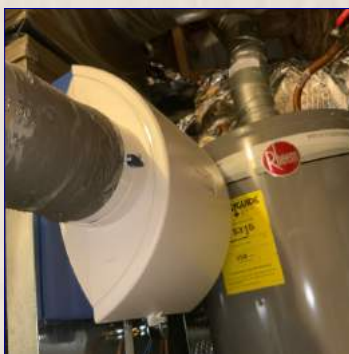
Humidifiers are not part of the home inspection. Recommend normal maintenance per the manufacturers specifications. Consult a licensed HVAC contractor as needed.

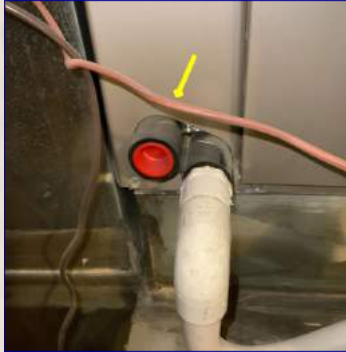
There is no secondary condensate protection installed on the air conditioner evaporator coil drain. This is a common practice, however, we recommend a licensed HVAC contractor install a secondary protection switch to help prevent damage to the furnace in the event that the drain becomes clogged and overflows.
